GALLATIN STREET

INTERSECTION STUDY

Existing Conditions Report

January 2024

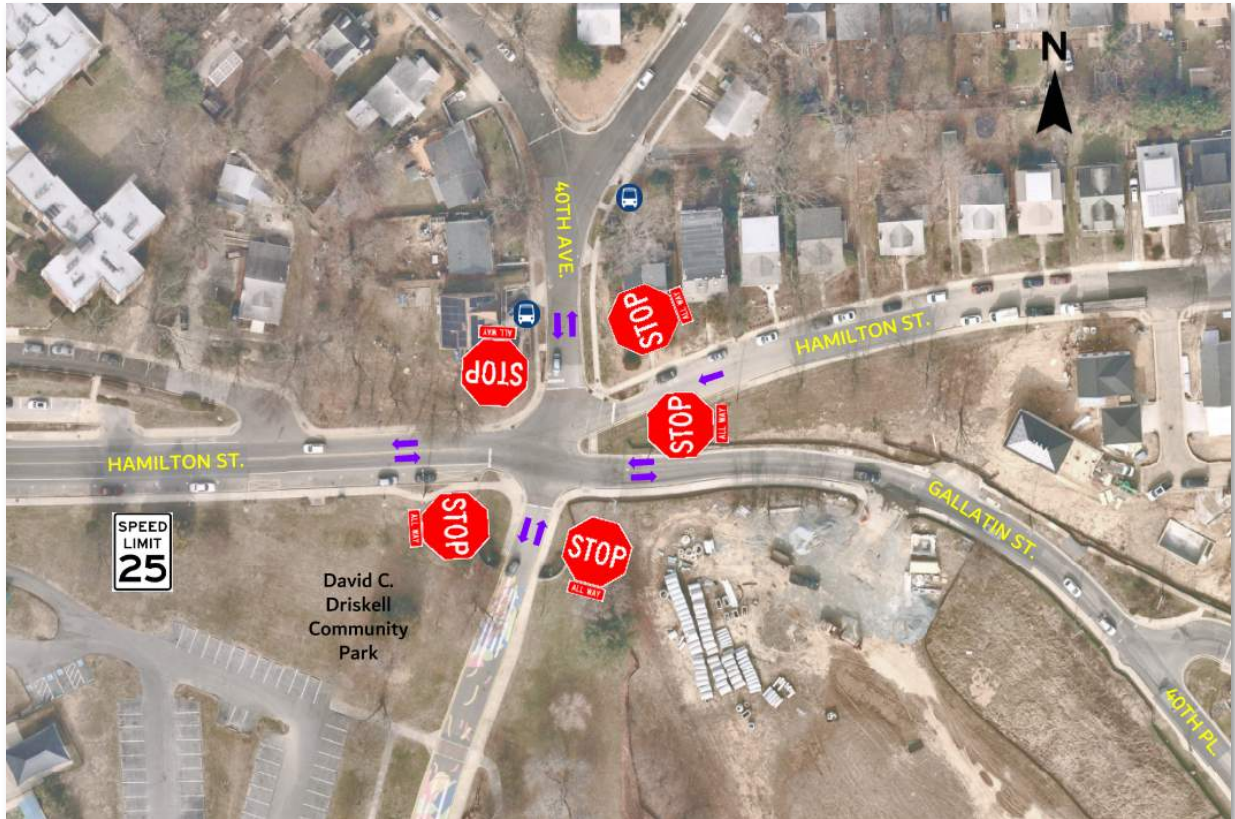
The Gallatin intersection is All Way Stop controlled (AWSC). The existing stop signs do not include the necessary R1-4 ALL WAY plaques. All roads are owned by the City of Hyattsville and are classified as local roads. The posted speed limit is 25MPH. The roadways that create this intersection are Hamilton St to the west and northeast, 40th Avenue to the north, Gallatin Street to the southeast, and the David C. Driskell Community Park Entrance. See map below.

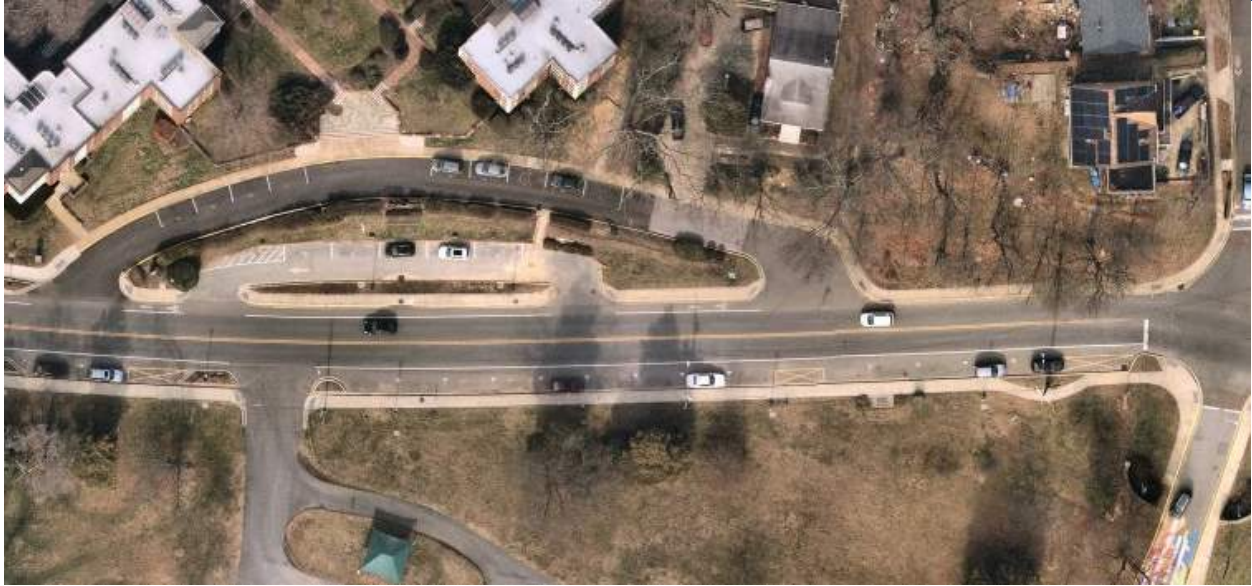
Hamilton Street – West Leg

The west leg of Hamilton Street is approximately 34' wide and consists of a two-lane road, one lane on each direction, with a parking lane on the south side (eastbound lane). As previously mentioned, this section of Hamilton Street has a posted speed limit of 25MPH, which is maintained throughout the corridor. Hamilton Street to the west begins at the West Hyattsville Metro Station.

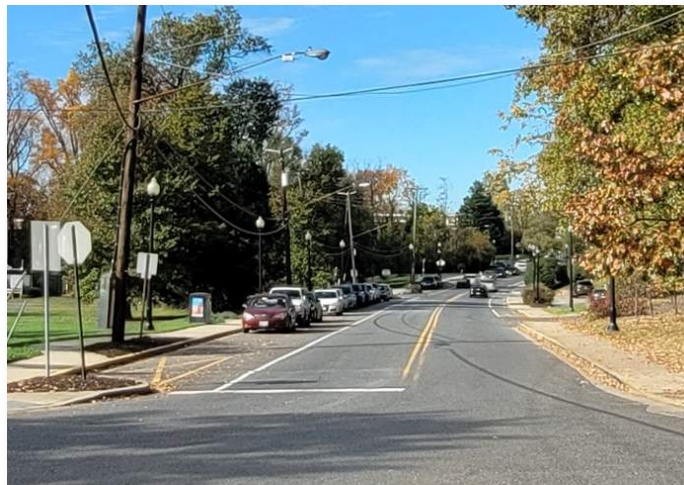
West of the intersection there is an entrance to the Hamilton Splash Park, which can also be accessed via the David C. Driskell Community Park entrance road. At the Gallatin Street

intersection there is a curb extension, only on the southwest corner, and the stop sign at this location is missing the “All Way” plaque.

1. All approaches should be upgraded to include R1-4 ALL WAY plaques supplementing R1-1 STOP signs.
2. All crosswalks should be upgraded to high visibility crosswalk markings.
3. Due to the low volumes, alternative configurations are not expected to result significant trip diversions to other neighborhood streets that would cause an adverse impact to residents and road users.
4. Alternative configurations may consider a variety of traffic management treatments and countermeasures identified in the Prince George's County DPW&T Neighborhood Traffic Management Program guidelines – mini roundabouts, semi-diverters, diagonal diverters, or full closures.

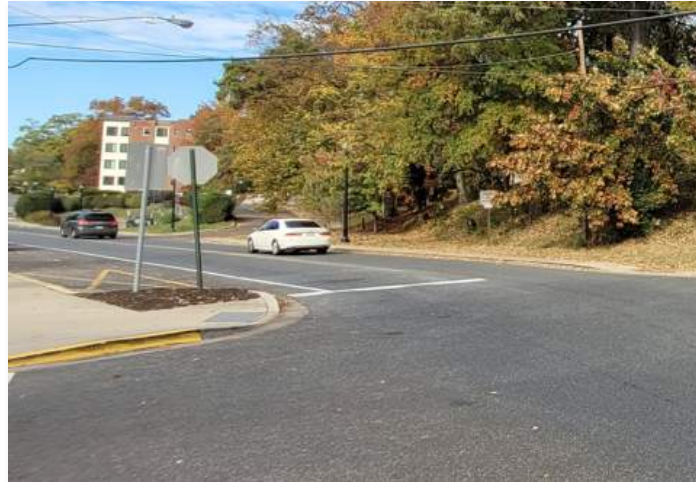
The westbound lane of Hamilton Street includes continuous sidewalks on both sides of the road. These sidewalks are right against the curb, with no green buffer between the westbound travel lane and the parking lane on the eastbound direction. The West leg of the intersection includes curb ramps with detectable warning surface, but they appear to be non-ADA compliant at initial inspection. The west leg has a designated crosswalk, but the pavement markings are faded and do not include high visibility markings.

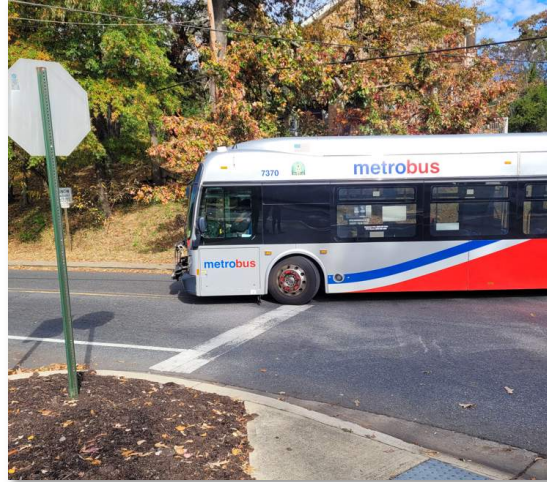
Above ground utilities around this leg of the intersection include utility poles with overhead lines and mast arm luminaires on the eastbound side as well as streetlight poles on both east and westbound sides.

Other utilities include drop inlets on both sides of Hamilton Street adjacent to the intersection and curb inlets east of the Hamilton Splash Park entrance. Fire hydrants can be found at approximately 180' west of the intersection and to the east of the Splash park entrance.

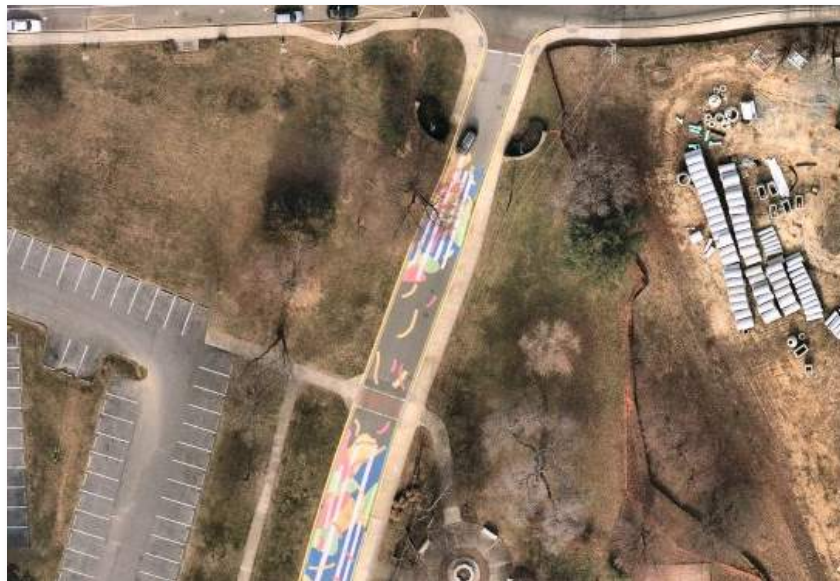
Park Entrance Road – South Leg

The David C. Driskell Community Park entrance road is about 20' wide. This is the main entrance to the park, which can also be accessed through the Hamilton Splash Park parking lot. It has two-way traffic and no parking along the road. The road extends south to the parking lot and soccer fields. The park entrance road includes asphalt painting.

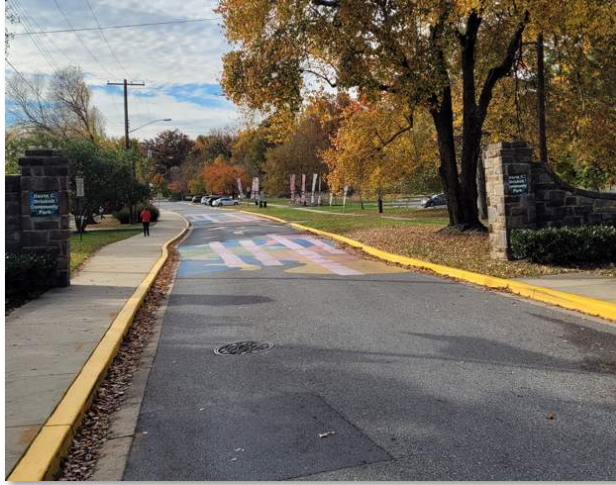
The Park entrance road includes a sidewalk on the northbound direction with no buffer. There's no sidewalk on the southbound side. The crosswalk at this leg of the intersection consists of stamped colored concrete and includes curb ramps with detectable warning surfaces.

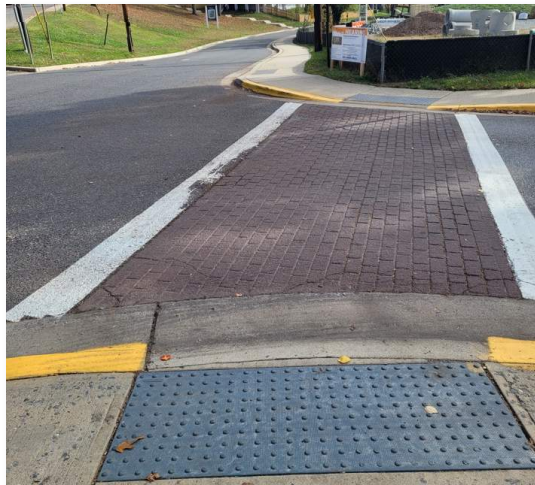
There is a mid block crossing approximately 190' south of the intersection, that provides access to the parking lot for the Hamilton Splash park. This crossing does not include pedestrian warning signage and the curb ramps are missing detectable warning surfaces.

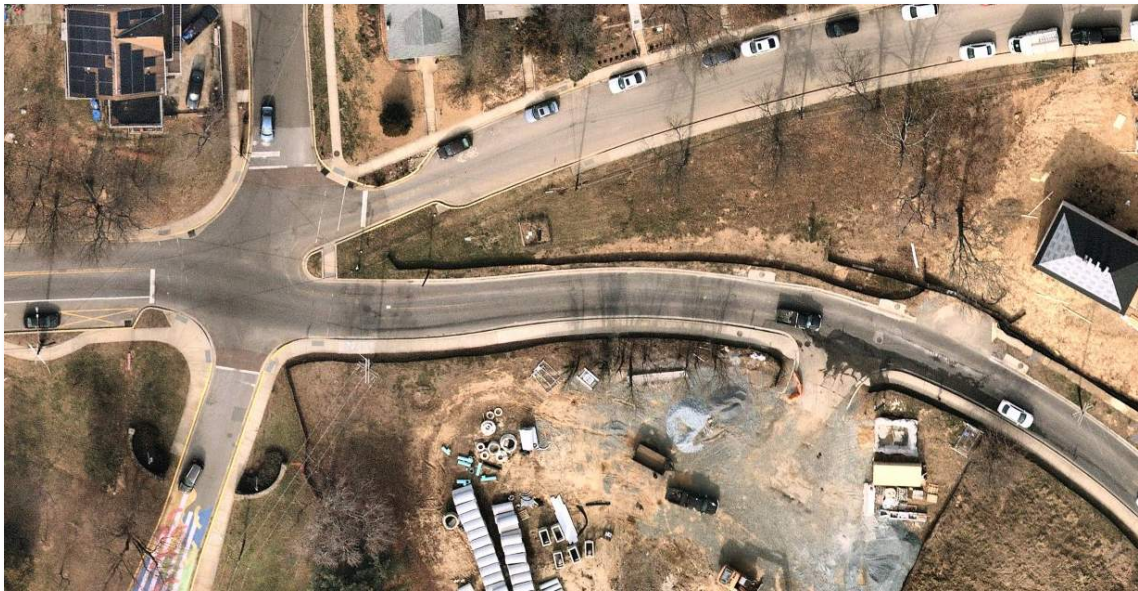
Gallatin Street – East Leg

Gallatin Street is a two-way road, approximately 20' wide with no on-street parking. It serves as a continuation of Hamilton St. on the eastbound direction as Hamilton Street, east of the intersection runs only to the west. This connection Gallatin and Hamilton Streets forces vehicles to significantly shift lanes since these two roadways are not aligned. The westbound lane on Gallatin Street is aligned with the Hamilton Street eastbound lane. The stop sign at the intersection is missing the "All-Way" plaque.

The east leg of the intersection is shared between Gallatin Street and Hamilton Street westbound. This condition, the angle in which both streets meet the intersection, in addition to the grade differential between them, creates a poor visibility scenario for drivers approaching the intersection on both roads. They are required to look behind them to identify if there is a vehicle on the adjacent street in order to assess right of way.

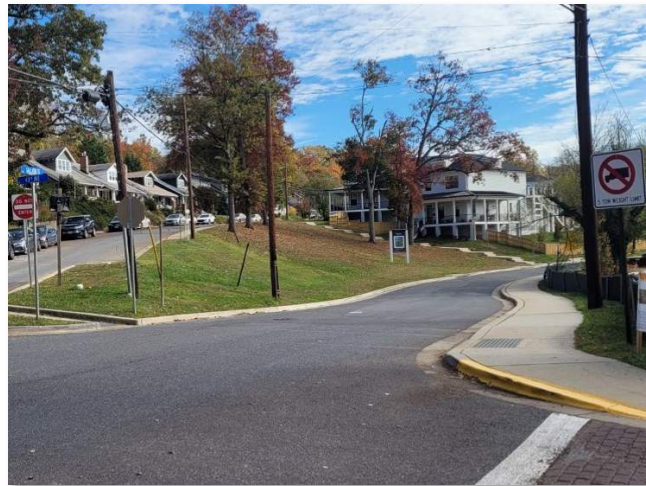
Gallatin Street. provides a continuous sidewalk along the eastbound lane. The crosswalk markings at the intersection are faded and do not include high visibility markings. The southeast corner includes a curb ramp connecting to a pedestrian opening at the tip of the separation between Gallatin Street and Hamilton Street. Both include detectable warning surfaces.

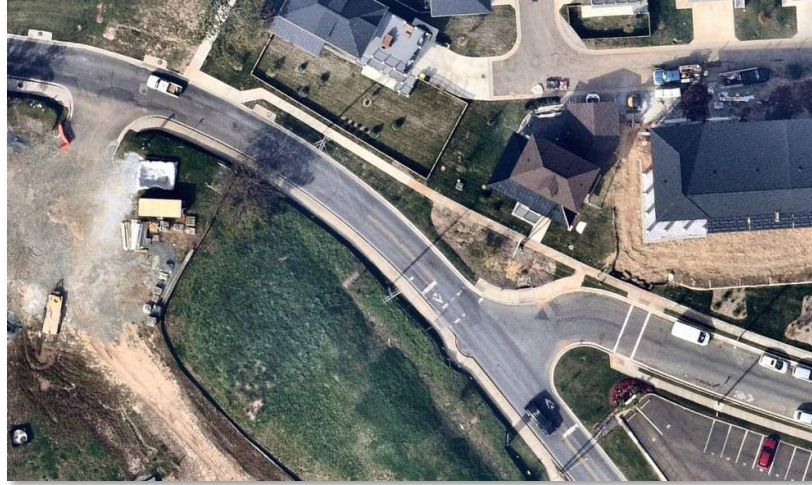
There are no dedicated facilities along Gallatin Street. The section east of the split with 40th Place includes shared lane markings, so it is assumed that the segment east of the intersection is also a shared lane.

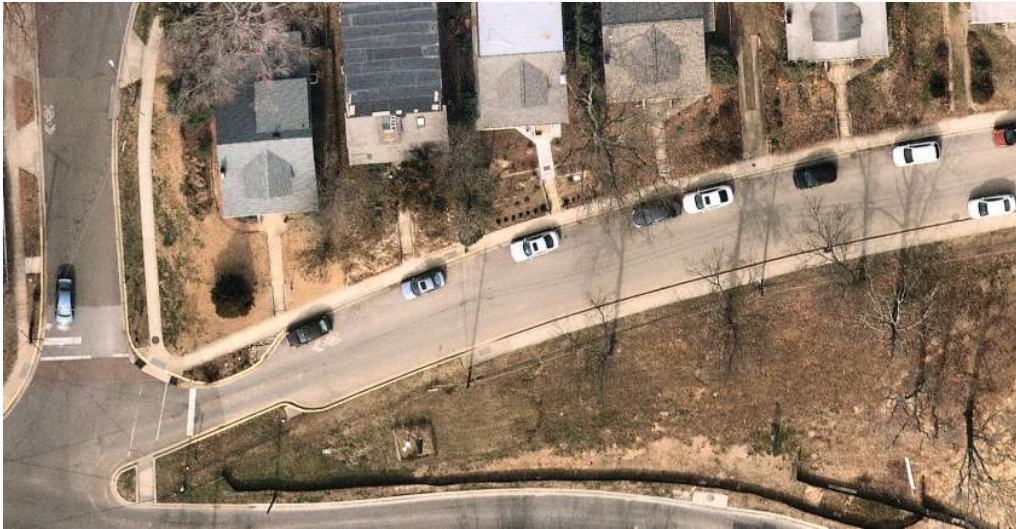
Hamilton Street – East Leg

This section of Hamilton Street consists of a one-way lane to the west. The approximate width is 27' and it includes on-street parking on both sides. There are a few residential driveways for the single unit homes located on the north side of the street. The intersection approach includes curb extensions on both sides of the road. The stop signs for this leg are missing the corresponding "All Way" plaques.

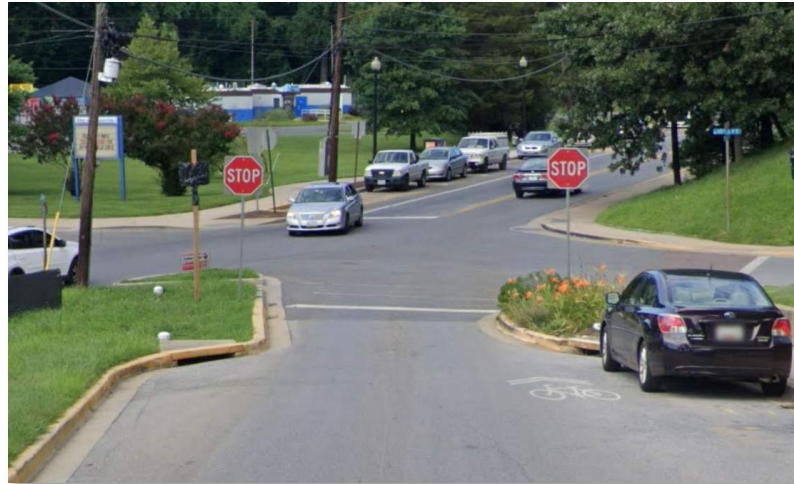
This leg of the intersection has a significant grade differential as the road elevation increases to the east. As previously mentioned, this differential, in addition to the angle in which Hamilton Street meets the intersection, and the fact that this leg is shared with Gallatin Street, all contribute to a poor visibility condition for drivers, in which they are required to look behind them to identify if there is a vehicle on Gallatin Street and assess right of way. To the east, Hamilton Street runs up to 42nd Avenue where it terminates at a T-shaped intersection.

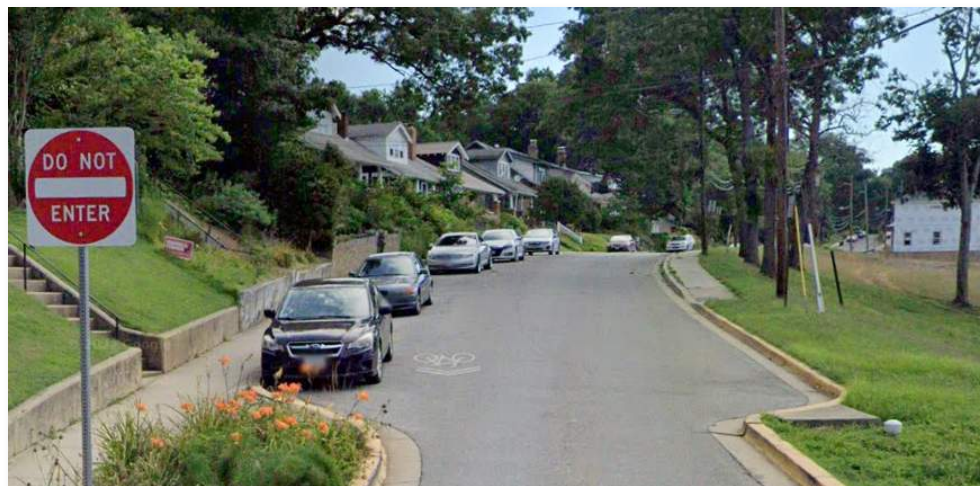
Hamilton Street includes continuous sidewalk only on the north side of the street. There is a sidewalk on the south side but it abruptly ends 110' east of the intersection. At this point there are curb ramps on both sides of the street but no marked or signed crosswalk.

At the Gallatin Street intersection, this leg includes a curb ramp on the north corner and the pedestrian opening at the separation between Hamilton Street and Gallatin Street to the

south. Both include detectable warning surfaces. These are connected by a crosswalk with faded line markings and no high visibility markings.

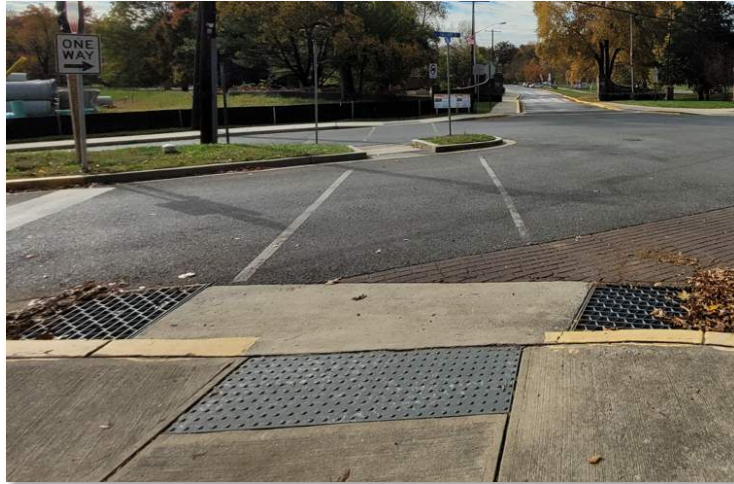
This leg of Hamilton Street includes utility poles with overhead lines on the south side of the road. Surface runoff is collected upstream of the curb extensions by curb openings on both sides of the street. In addition there are drop inlets on each side of the crosswalk at the northeast corner.

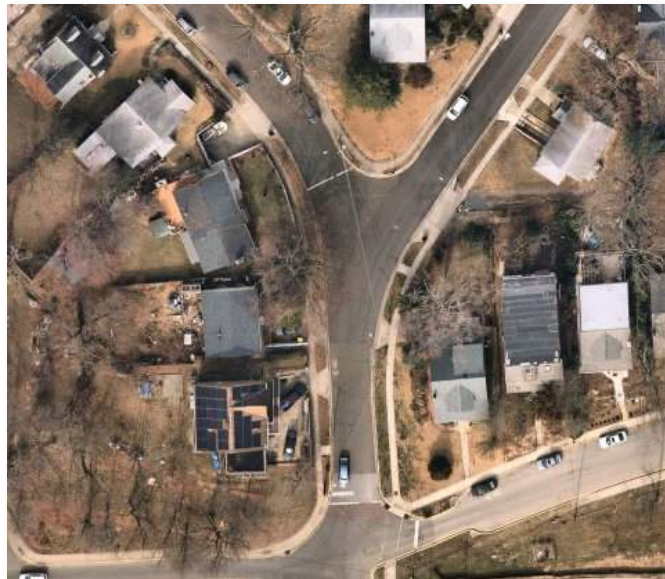
40th Avenue – North Leg

40th Avenue provides connectivity to the multiple east-west roadways to the north, this includes East-West Hwy (MD 410) via 41st Avenue and Jefferson Street which connects directly to the retail and restaurants on US Rt 1 north of the Art District. The section north of the Gallatin Street intersection is about 22' wide and it runs straight for approximately 150' where 39th Avenue southbound traffic merges into it. On-street parking is restricted on both sides of the street. There are a couple of residential driveways on both sides, just north of the intersection. The northwest corner includes a large curb radius to accommodate buses turning right onto Hamilton Street.

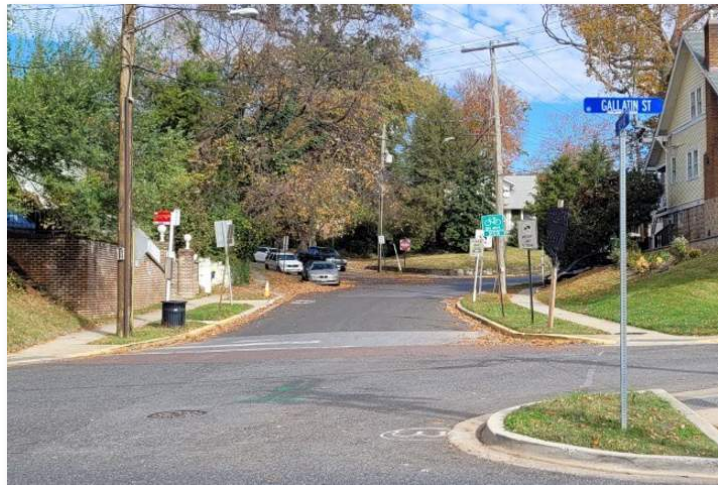
There are continuous sidewalks with green buffer on both sides of 40th Avenue. The intersection includes a colored stamped concrete crossing with curb ramps on both ends with detectable warning surface. This crossing is not ADA compliant as a drop inlet is located at the east end of the crosswalk. The markings for the crosswalk are faded. At the 39th Avenue merge point there are curb ramps but no designated crosswalk.

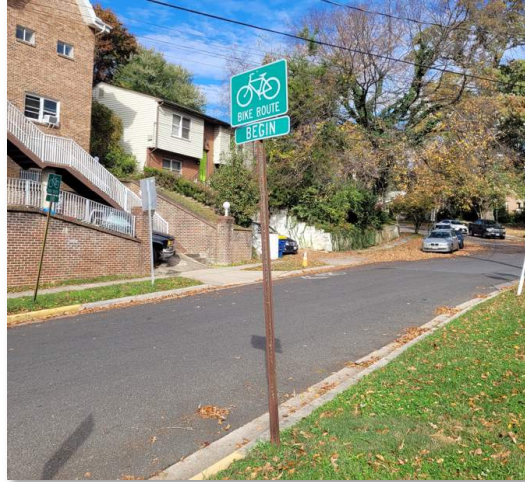
40th Avenue is marked and signed as a Bike Route as it serves as a key link in the City's bicycle network connecting the different shared lanes north of the intersection to the David C. Driskell Community Park.

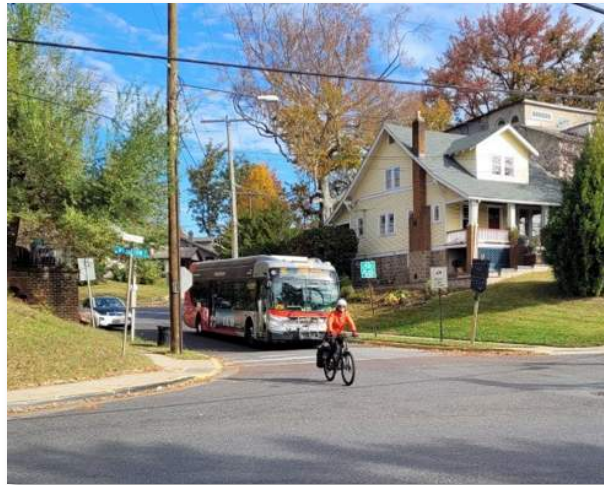
There are bus stops for both directions on 40th Avenue at approximately 33' and 140' north of the intersection for the southbound and northbound direction respectively.

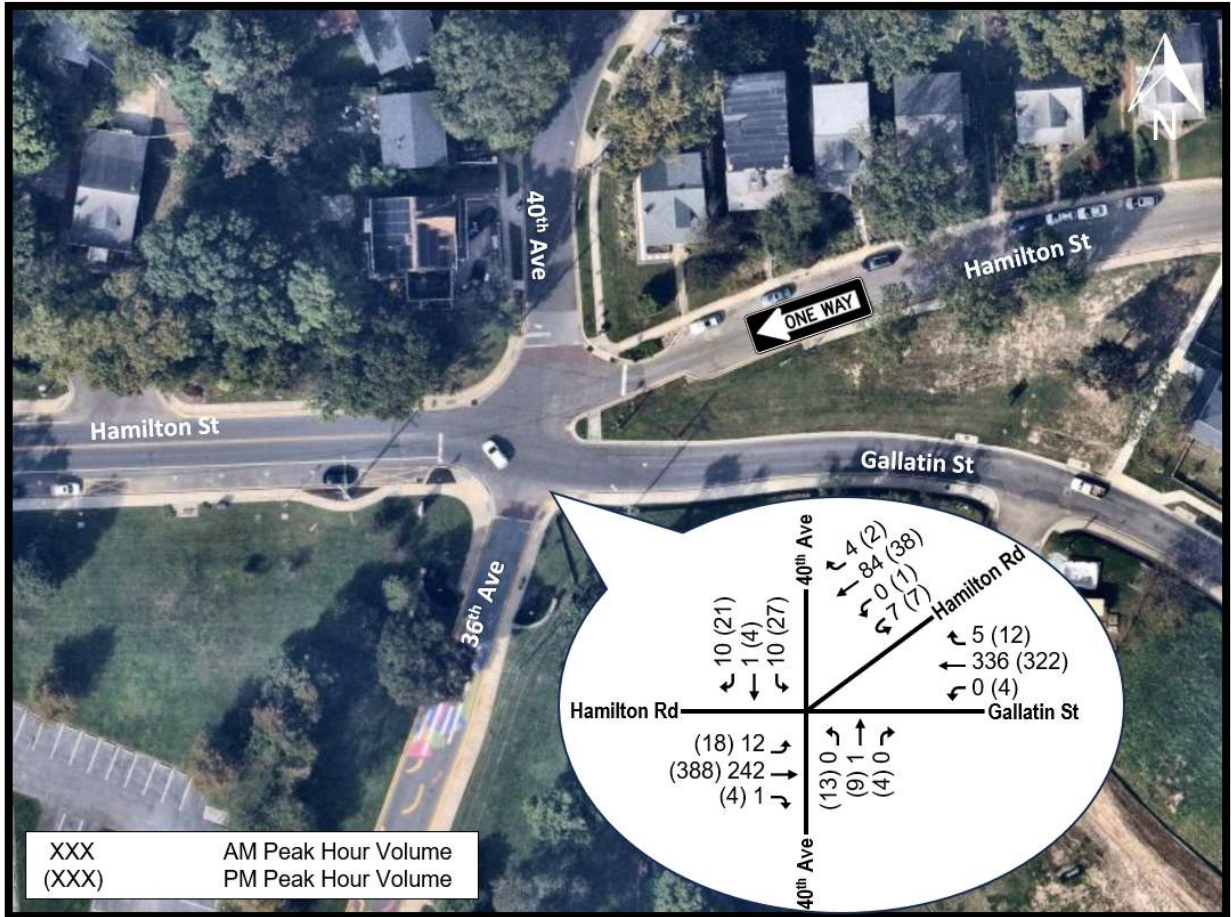
Peak Hourly Volumes at the Hamilton Street, Gallatin Street, 40th Avenue, and 36th Avenue Intersection

Volumes were recorded for the Hamilton Street, Gallatin Street, 40th Avenue, and 36th Avenue intersection on Tuesday, November 5, 2019. Peak hourly volumes were collected from 7:00 to 8:00 AM and from 4:30 to 5:30 PM (See figure below).

The intersection accommodates low volumes of traffic, both vehicular and pedestrian, during the peak hours. The west leg of Hamilton Street and the east leg of Gallatin Street are the primary approaches, but it is recommended that the intersection not prioritize the right of way of one approach or movement over another due to the unusual geometry of the intersection and the grade differential of the approaches.

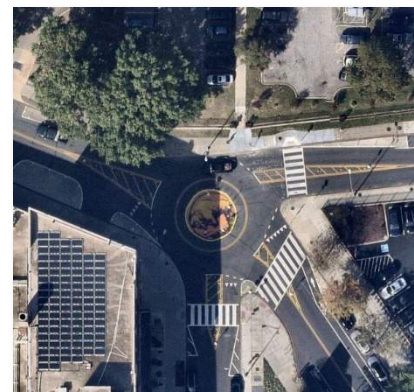
1 Mini-Roundabout Configuration:
The extents and characteristics of the intersection present an opportunity to install a mini-roundabout. These types of treatments are proven to efficiently reduce the number of collisions and the severity of vehicular crashes. The roundabout will simplify the right of way decision making and will make traffic movements more predictable, as vehicles will no longer be able to do U turns at the intersection. Special consideration must be given to preserve transit operation, as buses currently make turns to and from Hamilton St. and 40th Ave. Similarly, drainage will need to be considered and analyzed while exploring this opportunity. With or without the mini-round, there is also an opportunity for tactical urbanism such as asphalt painting at the intersection that can be an extension of the asphalt art

work on the park entrance road and the intersection of 40th Avenue and Jefferson Street. Alternatively, asphalt painting here can be used for placemaking or branding for the park.

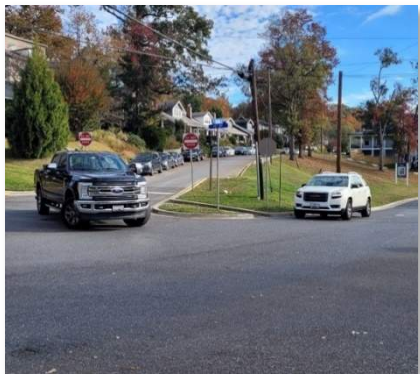
Currently, the east leg of Hamilton Street consists of a single lane in the eastbound direction exclusively. As mentioned before, Hamilton Street ends at 42nd Avenue. Reverting the direction of Hamilton Street to the westbound direction, for the block between 40th Avenue and 41st Avenue provides an opportunity to improve traffic along the intersection. With this modification, vehicles traveling west on Hamilton Street, either from this block or from 42nd Avenue, will have to use Ingraham Street and 40th Avenue to continue west, or use Jefferson Street depending on their desired destination.

This traffic modification will eliminate the existing conflict between vehicles approaching the intersection from Hamilton St. and Gallatin St. In addition, it will eliminate U turns at the intersection from vehicles traveling west on Hamilton wanting to go east on Gallatin St. This movement was constantly observed during the site visit and will be no longer needed as vehicles will be already traveling east.

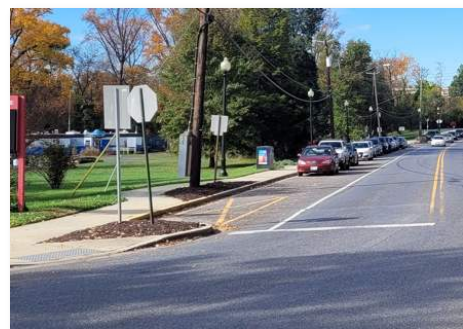
As previously mentioned, the west leg of Hamilton Street and the westbound lane of Gallatin Street are misaligned. The parking lane at the north end of Driskell Park on Hamilton Street presents an opportunity to slightly shift the west leg approach on Hamilton Street to reduce the lane shift downstream from the intersection. A few parking spaces, as well as the curb extension, will inevitably be lost with this design approach.

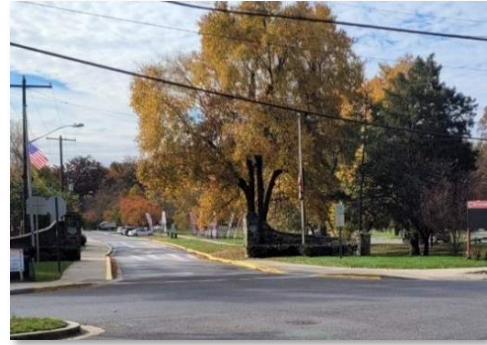
4 Coordination with Park Redevelopment:
The Driskell Park will be going under a major renovation, this includes the entrance road and pedestrian access. This presents an opportunity for the City and the design teams to collaborate and ensure that the improvements proposed by both projects are coordinated and provide seamless connectivity.

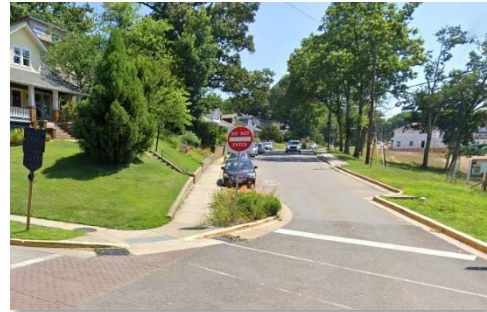
1 Elevation Change:
The existing topography, particularly at the northeast corner of the intersection, makes any improvement that requires a curb relocation very challenging since this will translate into earthwork movement, retention structures, and potential impact to private property and existing walls. Similarly, the drainage structures at this corner may have to be relocated or modified.

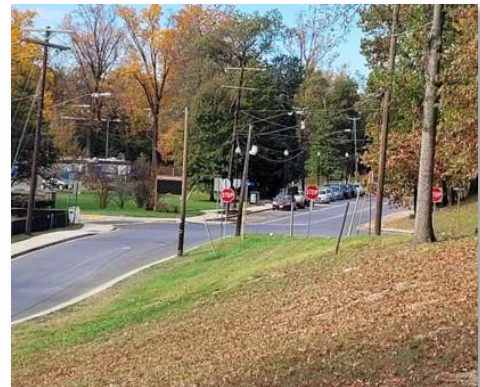
2 Roadway Geometry:
Maintaining the existing road alignments and configuration will require to maintain the existing pedestrian refuge at the end of the area separating Hamilton Street westbound and Gallatin Street. This space is essential for pedestrian to traverse the intersection as it not only shortens the distance to cross but also gives them better visibility.

Furthermore, any alternative that may require temporary or permanently acquiring land along this separation is unfeasible since it is part of a current development.

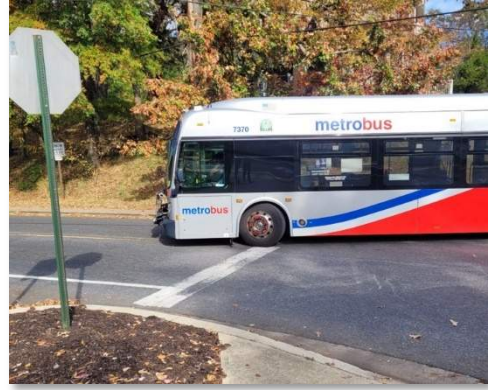
3 Transit Routes:
The presence of a transit route between Hamilton Street and 40th Avenue presents two constraints. One is that the large turning radius at the northwest corner of the intersection will need to be maintained. This limits the installation of curb extensions or any treatment that can induce a speed reduction as vehicles make this turn. Tightening this radius will make buses encroach onto the eastbound lane, which is a condition already occurring based on the observations during the site visit.

The second constrain is posed by northbound buses turning left from Hamilton Street onto 40th Avenue This maneuver requires a large envelope of roadway that may impede the installation of a mini roundabout. In other circumstances, turning maneuvers for larger vehicles, along any type of roundabout can be addressed by installing mountable aprons. However, this are not recommended along where public transit buses regularly operate.
