CITY OF
HYATTSVILLE

LOWER WARD 1 RESILIENT STORMWATER SYSTEMS PLANNING STUDY

September 2019

Low Impact Development Center, Inc. and Weston and Sampson

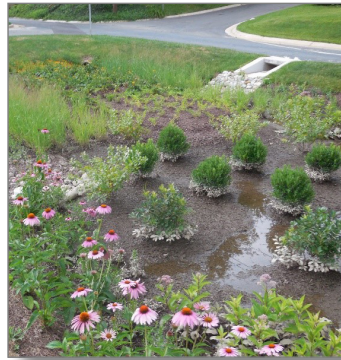
Bioretention. Bioretention captures stormwater runoff and allows it to slowly infiltrate through soil media. It provides water quality benefits by removing pollutants as the water flows through the soil and/or is taken up by native plants. Treated water may be routed back to the storm drain system. Bioretention can be integrated into areas like roadway medians, roadsides, or parking lot edges to directly treat runoff from impervious surfaces.

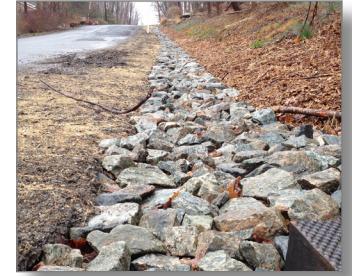
Infiltration Trench. An infiltration trench is a channel filled with layers of gravel, sand, and soil designed to capture and filter stormwater runoff. It helps remove pollutants and allows water to slowly soak into the underlying soil. An infiltration trench can be constructed in a variety of shapes but is often designed to fit into narrow, linear spaces.

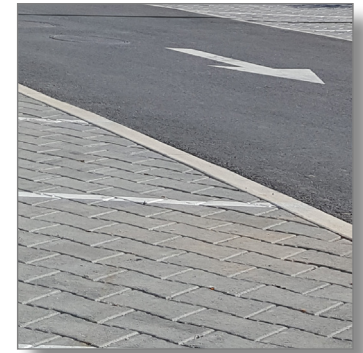
Permeable Pavement. Permeable pavement is used to pave bikeways, walkways, and low-traffic parking areas and streets. It allows water to flow through it instead of running off. It can be made of interlocking pavers (pictured at right) specially designed to allow water through gaps, or as porous asphalt or pervious concrete engineered to maintain a strong surface while allowing water to flow through.

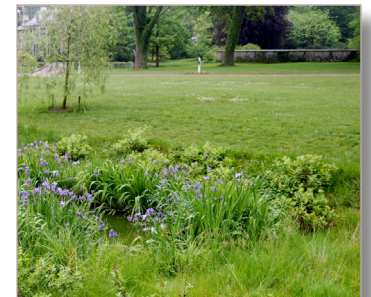
Pocket Wetland. A pocket wetland is a shallow, constructed wetland designed to treat stormwater runoff and filter pollutants from a small drainage area. They are suitable for areas where a high water table or groundwater can help replenish a shallow wetland pool during hot, dry weather.

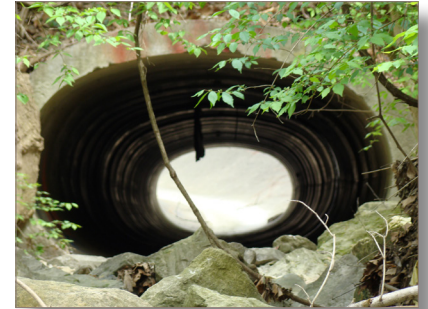
Culvert. A culvert allows water to flow underneath roads, bridges, and trails. Clogged and/or undersized culverts can become “pinch points” during rain events, causing channels to overflow their banks. Having adequately sized culverts that are regularly maintained is important for managing large storm events.

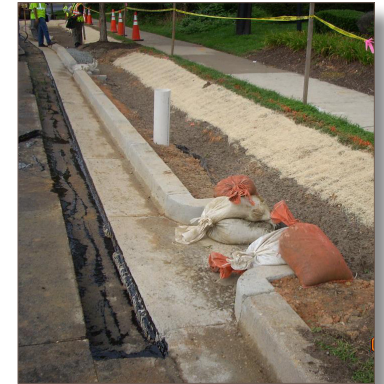
Curb and Gutter. Curb and gutter is designed to collect and concentrate water along a street or other paved area before being directed into the storm drain system. Installing and/or raising the height of the visible curb in areas along Rhode Island and Baltimore Avenues will help alleviate localized flooding by directing the water away from adjacent properties and into green infrastructure areas and other stormwater devices.

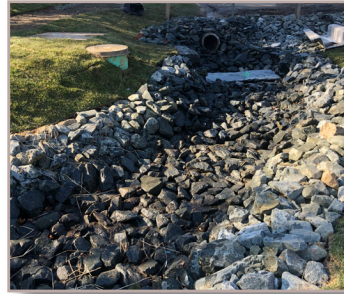
Outfall Protection. A storm drain outfall is the point where a storm drain pipe or channel discharges stormwater runoff to a waterbody. Damaged outfalls are stabilized or improved through rip-rap, bioengineering techniques and/or vegetation. This reduces the amount of local flooding and of sediment and erosion in downstream channels and wetlands.

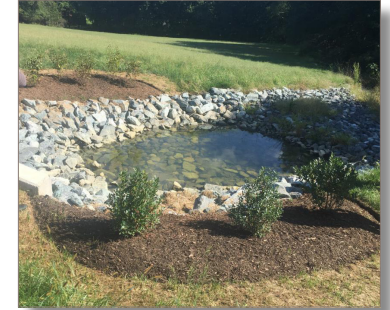
Stormwater Plunge Pool. A plunge pool is an excavated “pool” that can be placed at the end of a storm drain pipe or man-made channel to slow down the speed at which water is flowing. This protects the channel from erosion and allows sediment to settle out of the stormwater. This can simplify regular cleanout operations by encouraging sediment to settle in one place.

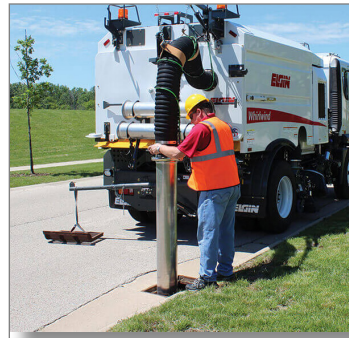
Storm Drain Insert. A storm drain insert is a device placed in a storm drain inlet to filter stormwater runoff. Depending on their design, they can capture solid debris and/or smaller pollutants like sediment. With regular maintenance to prevent blockage, they are a relatively simple and cost-effective way to prevent polluted runoff and litter from entering the storm drain system and eventually reaching waterways.

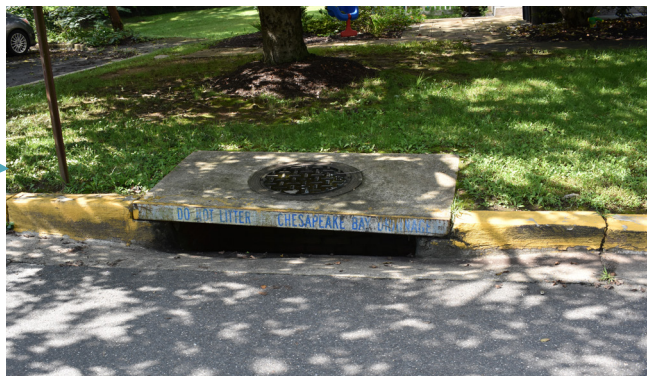
Figure 15. Existing storm drain inlet along 41st Place

Recommendation: Install curb inlet storm drain inserts along 41st Place to reduce the amount of solids and other pollutants that reach the Anacostia. Coordinate with DoE and the County’s Department of Public Works and Transportation (DPW&T) to install inserts in the four storm drains along 41st Place near Emerson St. and Decatur St.

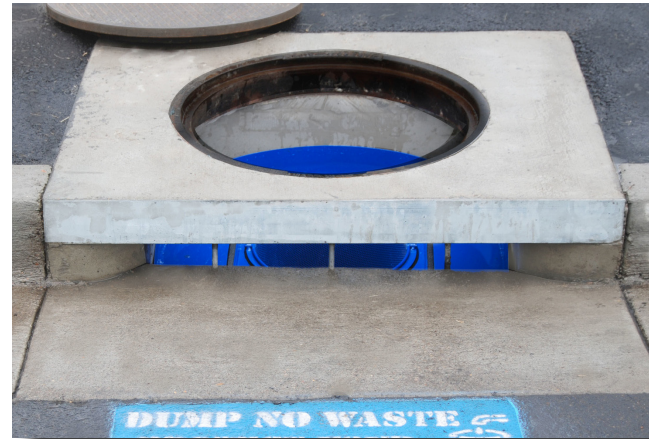
Description: A storm drain insert is a collection basket, tray, or bag placed under a storm drain inlet to filter out sediments and debris such as trash, leaves, and twigs. Some have more than one collection device and an underlying tray with a media filter to collect finer sediments or oils. Stormwater runoff enters and passes through the collection device before discharging into the storm drain pipe. Space is provided between the storm drain and the insert to allow larger volumes of water to bypass the system during high rains.

Figure 16. Example of a curb inlet storm drain insert

When considering inserts, it is important to ensure that the storm drain is in good repair and has room to accommodate an insert with adequate storage capacity. One that is too shallow as compared to the drainage area may lead to flooding.²³ Inserts must be regularly maintained by hand or with a small-scale vacuum truck.

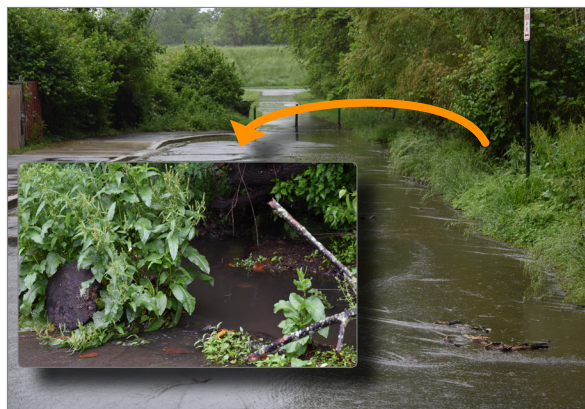
Description: 41st Street experiences issues with standing water during and after intense rain events. This has led to problems for adjacent homeowners and Melrose Park users. Information obtained from the Melrose Trail construction project and County GIS information was used to model stormwater flows. Two major causes of this problem were identified. First, the drainage ditch along 41st Street and the Melrose Park entrance is undersized and has not been maintained. It is clogged with sediment and debris and is overgrown with plants, giving water no place to go. Second, the culvert under the trail at the park's southwest corner is undersized (see opportunity #3).

Figure 17. Existing swale along 41st Street

Recommendation: Widen the channel to 15-20 feet and maintain the grass in a mowed condition or provide a cobbled bottom. Add a plunge pool near the outfall to slow down incoming runoff and improve overall stability. This will also simplify maintenance by allowing the sediment to settle out in a relatively restricted area, making it easier to scoop out.

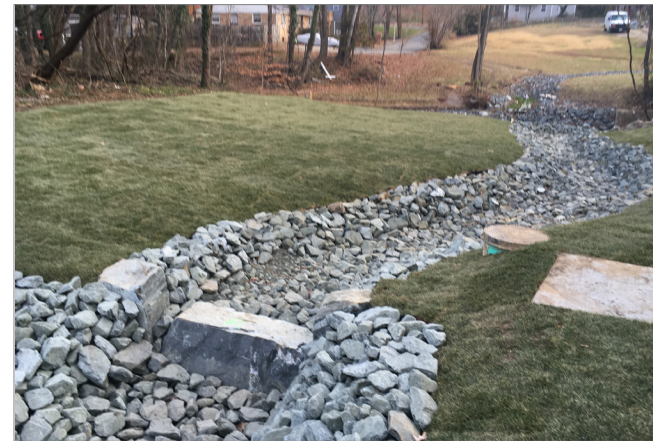
Figure 18. Outfall stabilization project in Suitland, MD

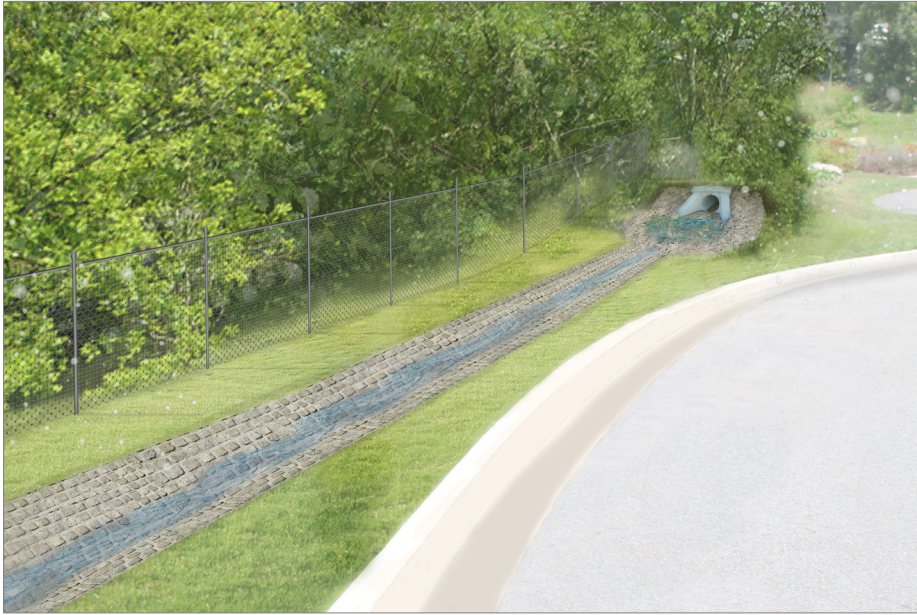
Figure 19. Rendered overlay of 41st Street outfall restoration project. A plunge pool is installed directly below the outfall.

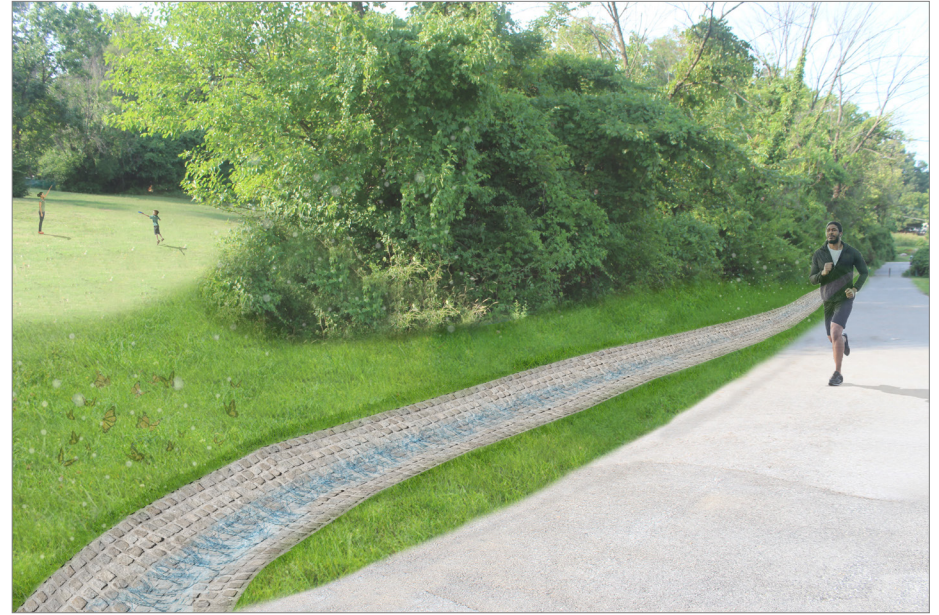
Figure 21. Rendered overlay of cobble bottom swale. It extends towards intersection with Northwest Branch Trail.

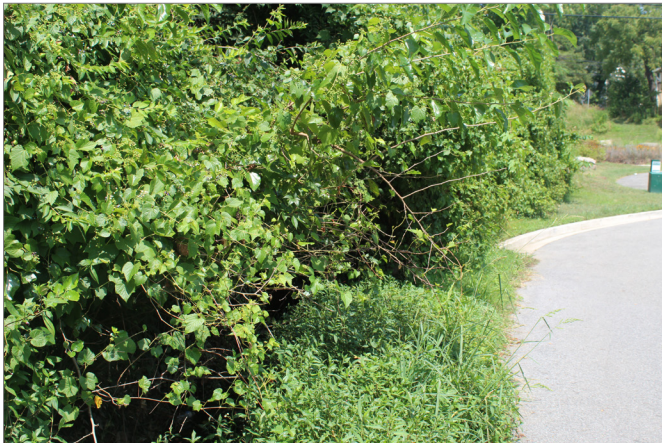
Figure 20. Existing grass channel along 41st Street. The channel is built up with sediment and debris and filled with overgrown plant material.

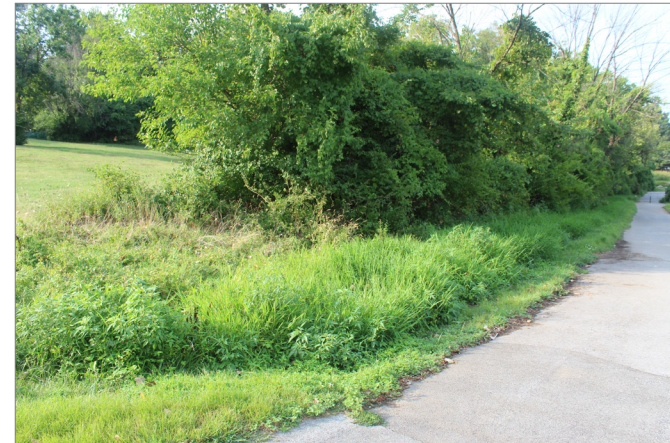
Figure 22. Existing conditions within Melrose Park along 41st Street trail

Recommendation: Evaluate the opportunity to incorporate pocket wetlands with the outfall protection project (see project #2). Coordinate with DoE and M-NCPPC.

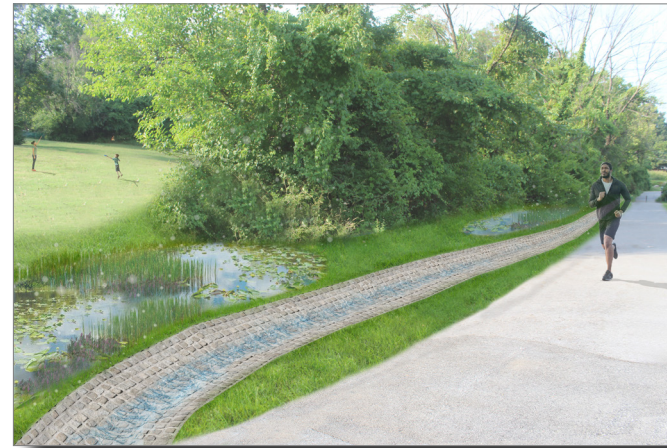
Figure 24. Rendered overlay of pocket wetlands. Area is in Melrose Park along 41st Street trail.

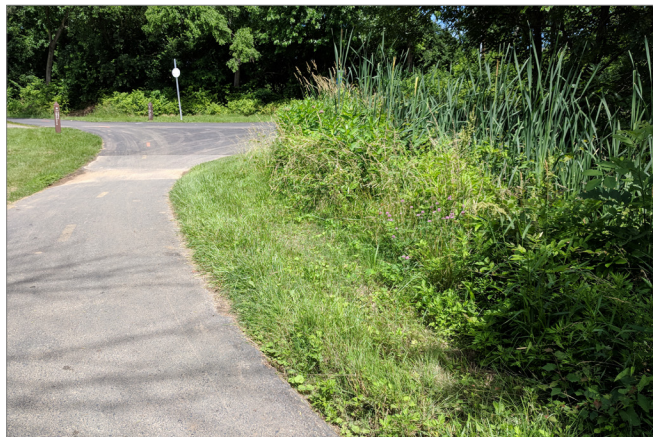
Figure 23. Current conditions of channel along trail. The area is overgrown with water tolerant plants.

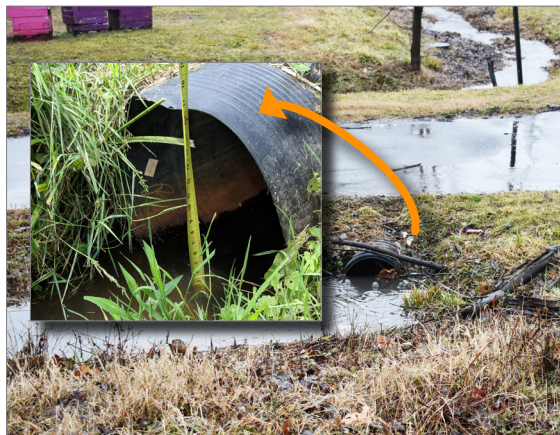
Description: The existing culvert at the intersection of the 41st Street trail and the Northwest Branch Trail is 18 inches in diameter. While the culvert was adequately size for small events, the increased amount of precipitation falling in heavy events means that it is now prone to flooding and failure. During heavy rains, huge volumes of water quickly fill the drainage system and overwhelm the culvert. This causes water to back up on the upstream side and overflow across 41st Street, resulting in concerns with localized flooding and increased erosion. Undersized and/ or poorly maintained culverts can become clogged by debris,

Figure 25. Existing culvert under 41st Street trail. Areas is near Northwest Branch trail intersection.

making them even more vulnerable to being overwhelmed during intense rain events. The 41st Street trail culvert was observed to be obstructed with sediment and debris during multiple site visits.

Recommendation: Coordinate with M-NCPPC and DPW&T to replace the existing culvert with one adequately sized to pass the current and future 10-year 6-hour storm event.

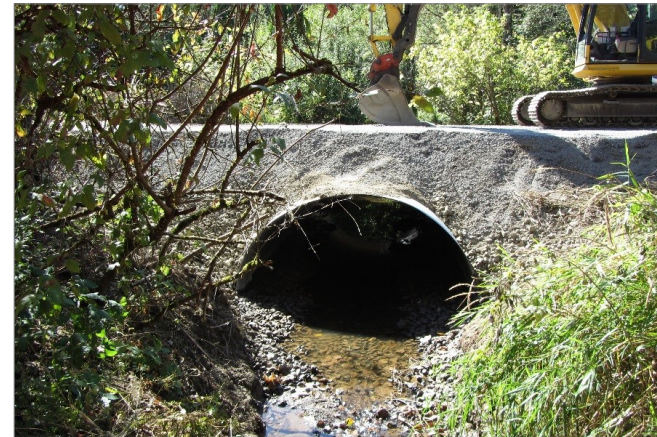
Figure 26: Culvert replacement project under a park trail

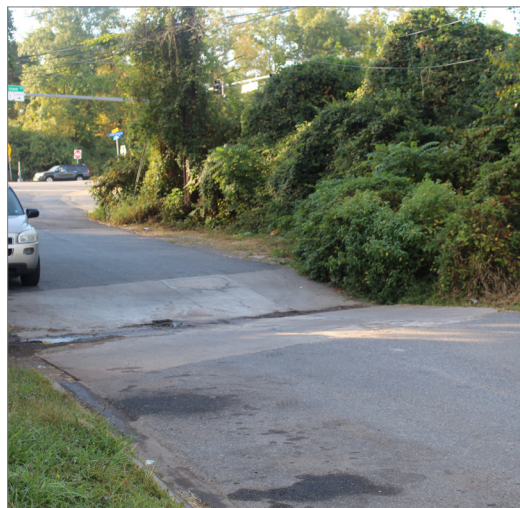
Description: A paved ford or dip was previously installed on 41st Place as a low water stream crossing. Such crossings can be a low-cost alternative to culverts for roads with light traffic, but the wear and tear of traffic going over the 41st Place crossing has caused it to erode. This has led to safety and water quality concerns.

Figure 27. Current conditions along 41st Place

Recommendation: Design and install an improved small waterway crossing on 41st Place that supports the appropriate load rating and allows water to pass unobstructed under the roadway.

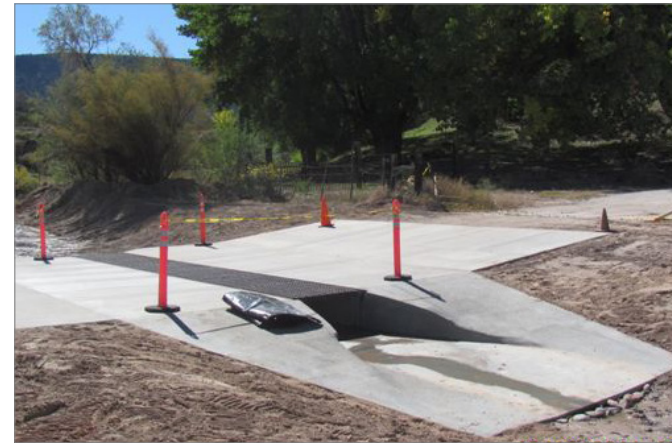
Figure 28: Example of a water crossing

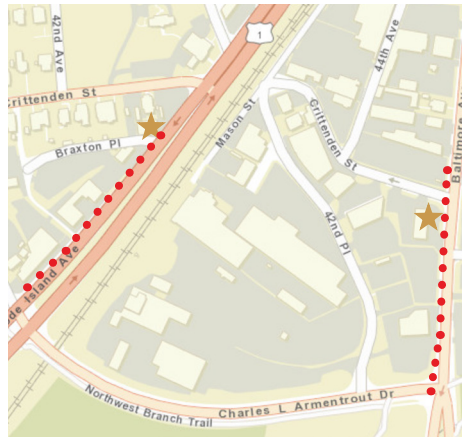
Description: The current curb and gutter system along the southbound sides of Rhode Island and Baltimore Avenues does not sufficiently prevent stormwater runoff carried in the roadway from overflowing into business properties located directly along the street. During more intense rain events, stormwater runoff in the roadway can exceed the height of the mountable curbs. The Maryland State Highway Administration’s (SHA) proposed Rhode Island Avenue Trolley Trail extension includes replacing the southbound shoulder with an ADA-compliant sidewalk. This should provide better protection from flooding

Figures 29. Existing curb-and-gutter along Rhode Island Ave southbound

Recommendation: Support SHA’s efforts to incorporate ADA-compliant sidewalk and improved curb and gutter on Rhode Island Avenue between 41st Place and Braxton Place. Coordinate with SHA to similarly improve curbing along Baltimore Ave in accordance with SHA standards.

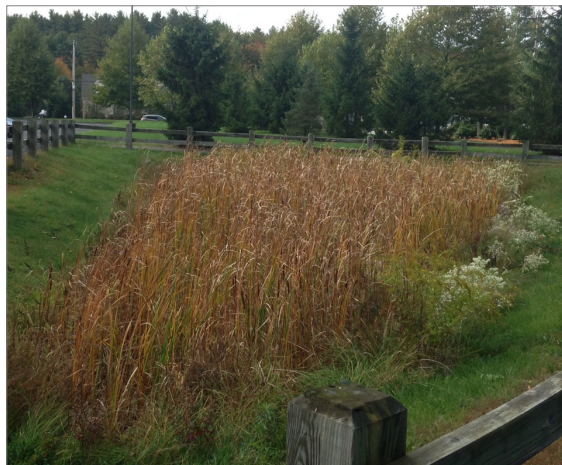
Figure 31. Example of a submerged gravel wetland

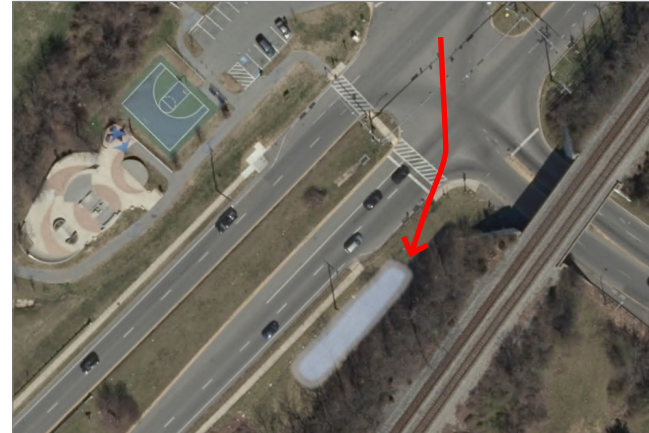
Figure 32. Conceptual overlay of submerged gravel wetland

Recommendation: Support SHA’s efforts to engage CSX and install a submerged gravel wetland near the intersection of Route 1 and Charles Armentrout Drive.

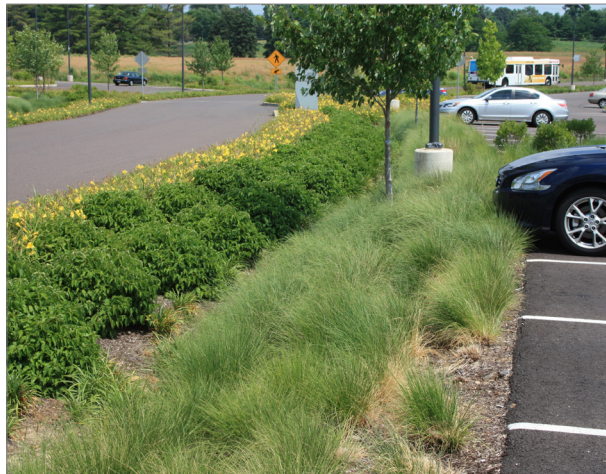
Figure 33. Bioswale along edge of hospital parking lot in East Norriton, Pennsylvania

Recommendation: Seek opportunities to improve drainage to the existing culverts and improve water quality by reducing impervious area and adding a bioswale along the property's southern edge.

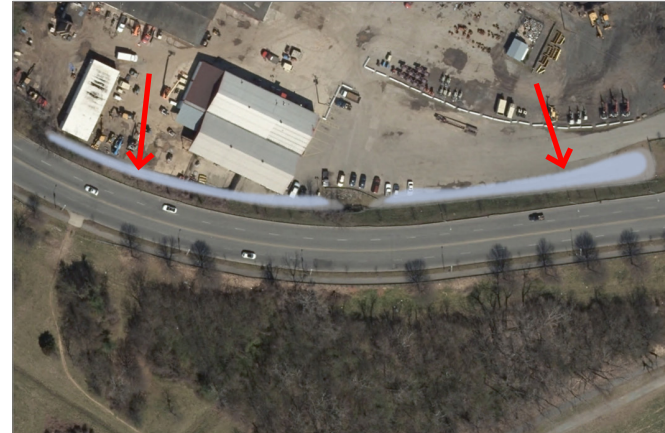
Figure 34. Conceptual overlay of bioswale along Charles Armentrout Drive

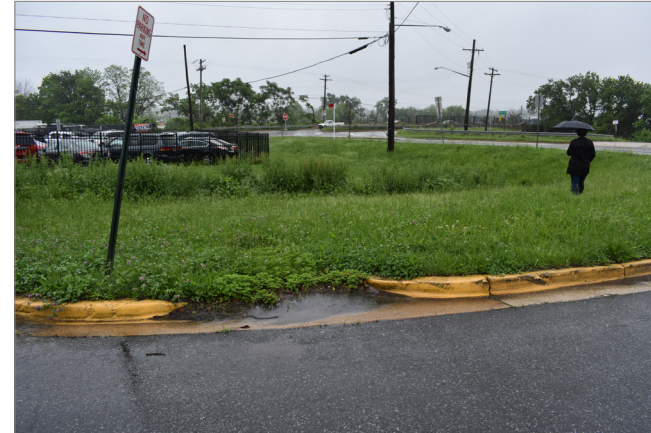
Figure 36. Existing conditions along 42nd Place and Charles Armentrout Drive

Description: The right-of-way along 42nd Place just north of Charles Armentrout Drive is owned by the City of Hyattsville. This area was identified by the City as one that often experiences standing water during and after heavy rain events. Model simulations of existing conditions provided similar results. The subcatchment area (#3C) is more than 80% impervious and includes a mix of commercial and light industrial businesses (e.g., vehicle service centers, car dealerships). Pollutant runoff from these properties is assumed to be higher than in residential areas.

Recommendation: Design and install a submerged gravel wetland or similar stormwater practice to reduce issues with standing water along 42nd Place and reduce and filter stormwater from upstream pollution-generating activities.

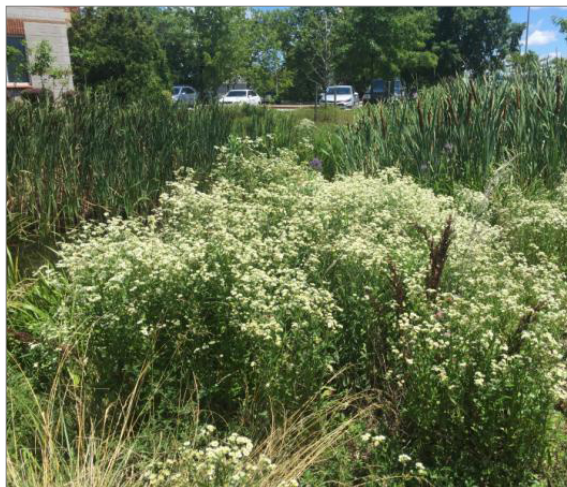
Figure 35. Plants growing in a submerged gravel wetland

A submerged gravel wetland was identified as an appropriate stormwater treatment practice because of its ability to maximize the removal of pollutants and to address concerns with localized flooding and standing water. It has also been identified by City staff as a good candidate for outreach to nearby business owners to demonstrate how green infrastructure can be incorporated on commercial properties.

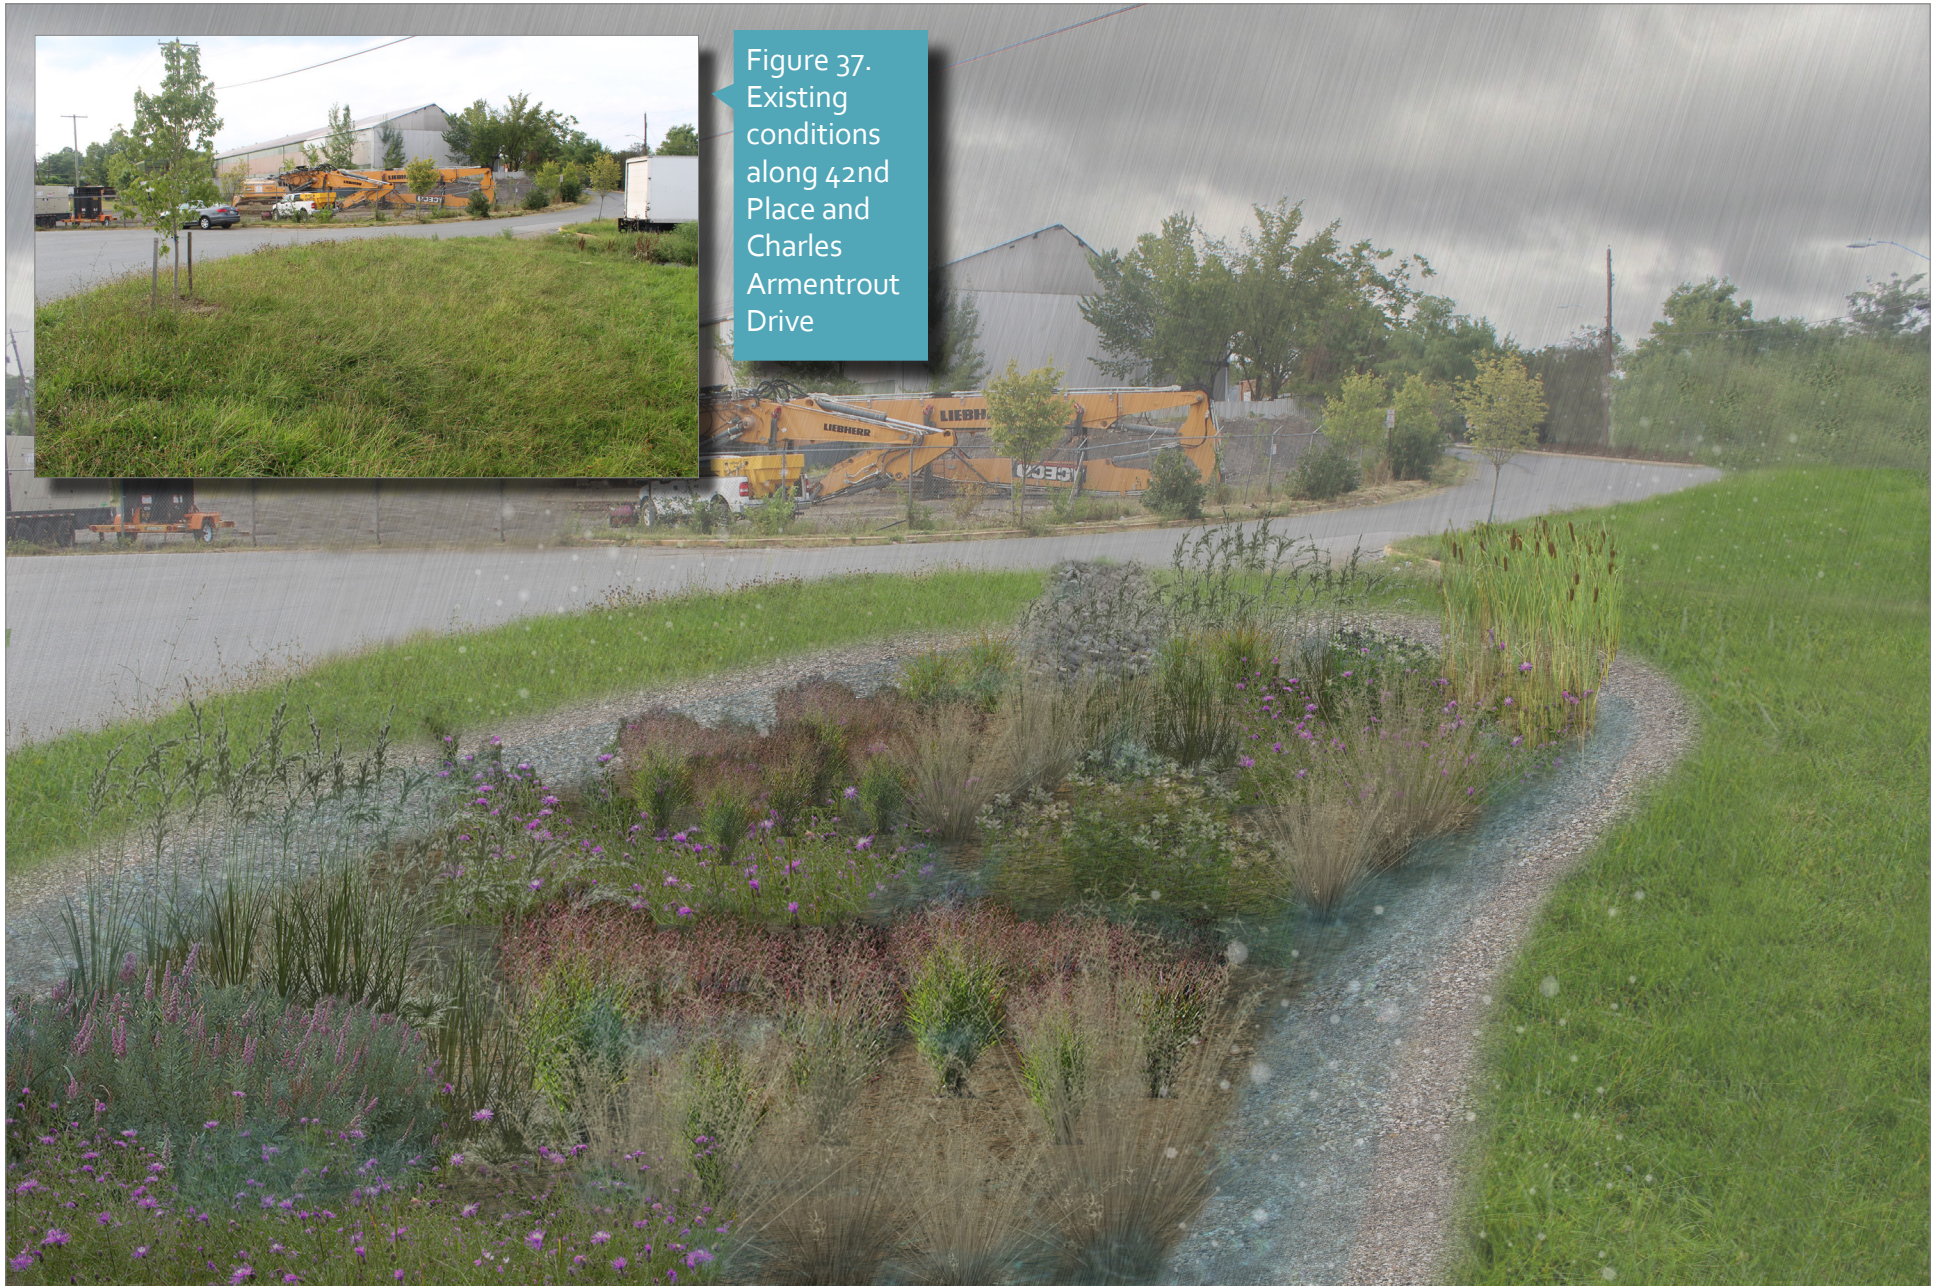
Figure 37.
Existing
conditions
along 42nd
Place and
Charles
Armentrout
Drive

Figure 38. Rendered overlay of submerged gravel wetland project along 42nd Place and Charles Armentrout Drive

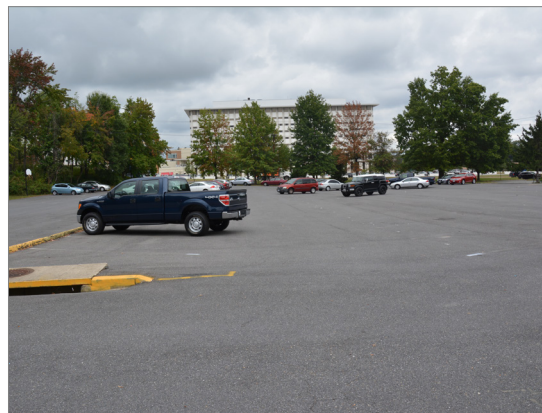
Figure 40. First United Methodist Church (after). The lot was redesigned to incorporate permeable parking pads and bioretention.

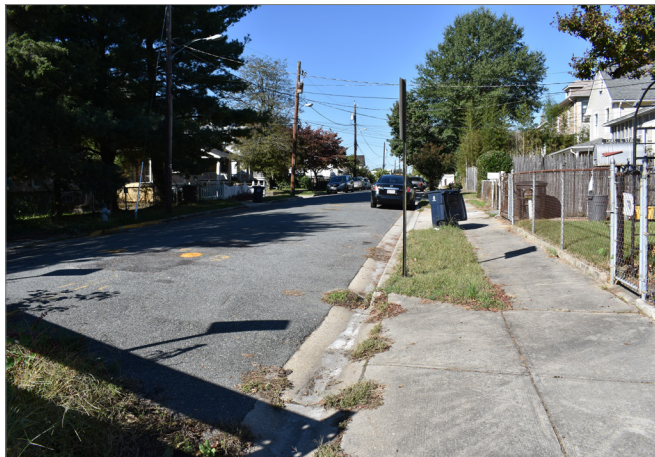
Description: The neighborhoods east of Baltimore Avenue lack a storm drain system. Runoff generated in this area runs along the roadways before flowing down to the Northeast Branch of the Anacostia River. The neighborhood streets are small with narrow roadbeds that accommodate a travel lane and on-street parking. Low-volume roads also mean that less sediment and debris is produced, making the right-of-way appealing for bioretention facilities and/or permeable pavement.

Figure 41. Existing right-of-way conditions

Recommendation: Explore green infrastructure opportunities within the neighborhood east of Baltimore Avenue. Engage the public to obtain community input and prepare designs using detailed field survey and geotechnical information.

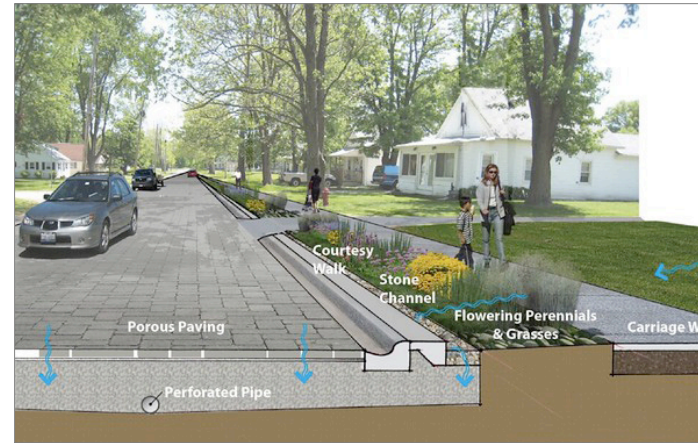
Figure 42. Rendering of a residential green street

Opportunities exist to incorporate green infrastructure into the right-of-way of the residential sections along Emerson Road, Burlington Street, and Buchanan Street. Green infrastructure practices such as bioretention, infiltration, and permeable pavement may be employed within the road rights-of-way to reduce runoff and minimize pollution.
